Seeing beneath the surface

- a performance comparison of non-destructive technologies for concrete inspection

Sanat Wagle, PhD, Elop AS
Kamal Raj Chapagain, PhD, Elop AS
December, 2020

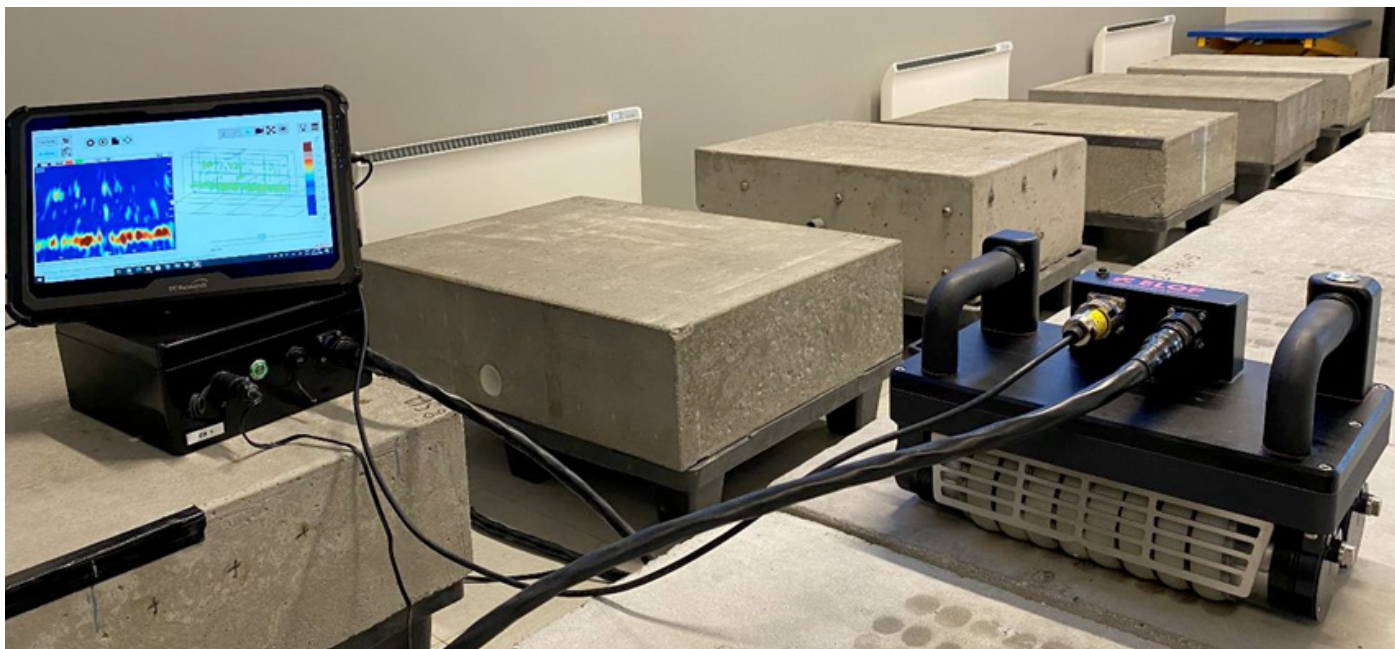
Test setup with 10 different concrete specimens

The following pages summarize the results of a number of tests and comparisons, carried out at Elop's R&D facility in Hamar, Norway. To compare the performance of different nondestructive inspection technologies we have used 10 concrete specimens, each with different characteristics, e.g. concrete mix ratio, density, and thickness of rebars, cracks, air pockets, delamination, drilled holes, tendon ducts etc. Measurements have been performed with four different instruments: Impact echo, UPV, Ultrasound Tomography, and Elop Insight scanner, to compare the capabilities of the Elop Insight scanner to these technologies. Also, the test measures the repeatability of the Elop Insight scanner under the same measurement conditions.

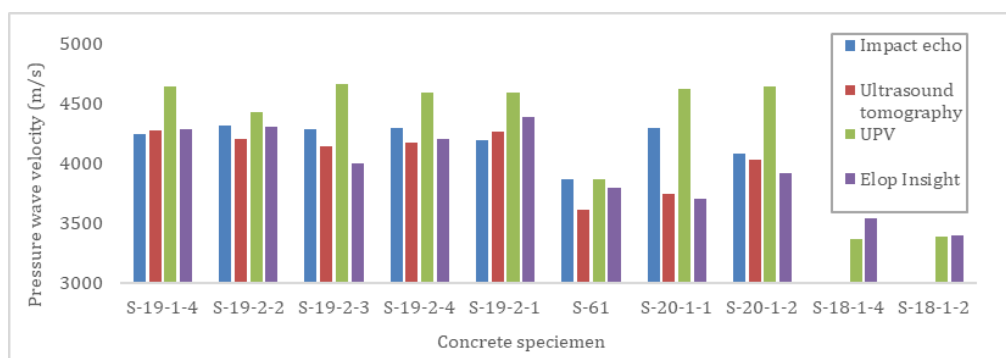
Figure 2:

Pressure wave velocity calculated from different instruments for different concrete specimen, named as S-61, S-18-1-2, S-18-1-4, S-19-1-4, S-19-2-1, S-19-2-2, S-19-2-3, S-19-2-4, S-20-1-1 and S-20-1-2

The ultrasonic velocity of the concrete is an indirect measurement of strength of the concrete. For a good quality concrete, the pressure wave velocity should be in the range 3500 – 4500 m/s. However, the ultrasonic velocity of concrete depends upon the aggregate sizes, amount of rebars and concrete mix ratio (cement, water, air, aggregates). The ten different concrete specimens at Elop's premises were used for velocity measurement with four different instruments (Impact echo, UPV, Ultrasound tomography and Elop Insight). The measured pressure wave velocity for different samples are shown in Figure 2 below.

As we can see from the figure, the pressure wave velocities measured from different techniques are very close (within 5-10 %). The results obtained from UPV are generally slightly higher than obtained by other equipment (10-15%). The impact echo was not giving correct values when it was measured on the surface above rebars. The obtained velocities from Elop Insight were also verified by the backwall location from 3D images generated by Elop Insight.

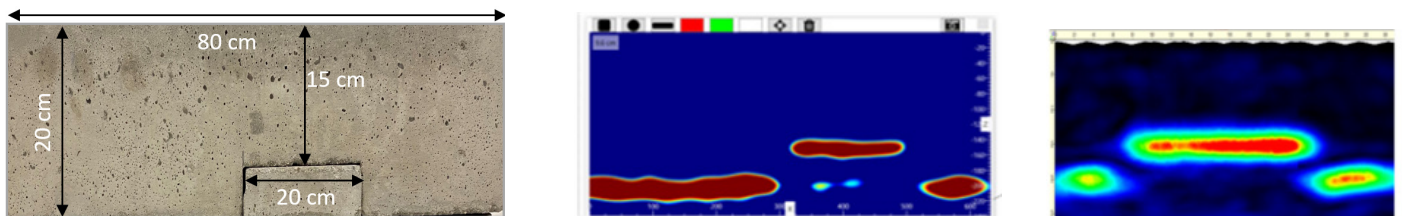
Figure 3:

Concrete specimen S-18-1-4 has a delamination of area 20 cm x 60 cm at 15 cm from the top surface. The gap between the two concrete blocks is in mm range. D-scan images of the concrete specimen for the central slice obtained from Elop Insight is shown in the left figure. The figure to the right is the slice obtained using Ultrasound tomography for the same specimen at the same location. The reflection from delamination around 15 cm is clearly visible together with back-wall echo at 20 cm in both the images.

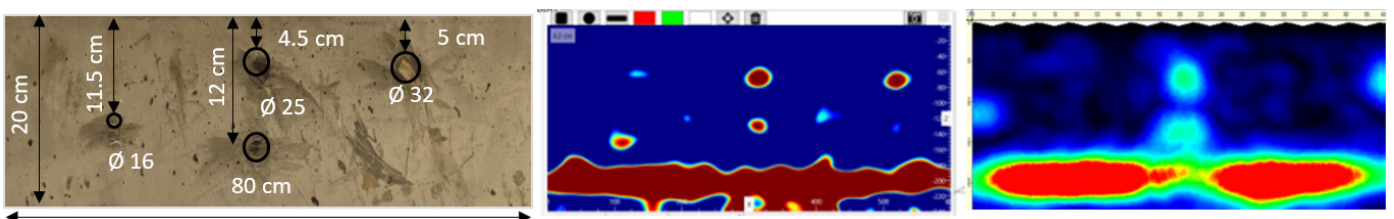
Figure 4:

Concrete specimen S-19-1-4 has four rebars with diameters 16 mm, 25 mm, and 32 mm at different locations. D-scan images of the concrete specimen for the central slice obtained from Elop Insight is shown in the left figure. We see clear reflections for all the rebars along with back-wall. The figure to the right is the slice obtained using Ultrasound tomography for the same specimen at the same location which also shows the presence of all four rebars.

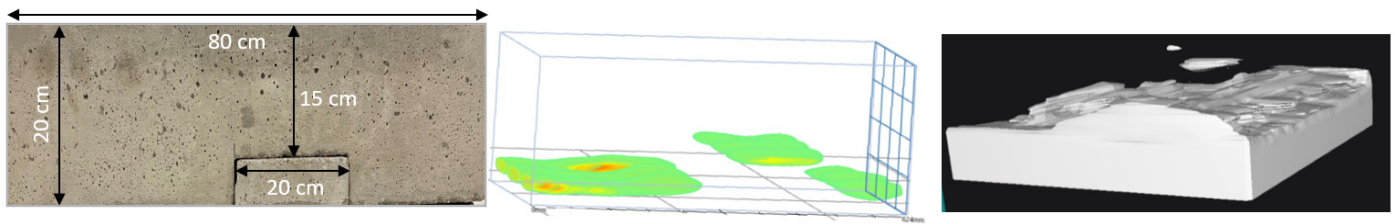
Figure 5: To the right is the concrete sample. 3D volume for Elop Insight scanner using 3 scan lines is shown in the middle figure whereas 3D volume generated for GPR using 14 scan lines is shown in figure to the right. The delamination gap between two concrete slabs is less than 5 mm. The delamination around 15 cm is clearly visible together with back-wall echo at 20 cm in Elop Insight. However, for GPR, the delamination was not clearly visible.

Elop Insight was stronger in air/delamination detection compared to GPR. The GPR scanner was stronger in rebar detection compared to Elop Insight. The GPR was also able to detect big air tubes and delamination, which was a couple of centimeters thick but was not able to detect a sub-cm delamination.

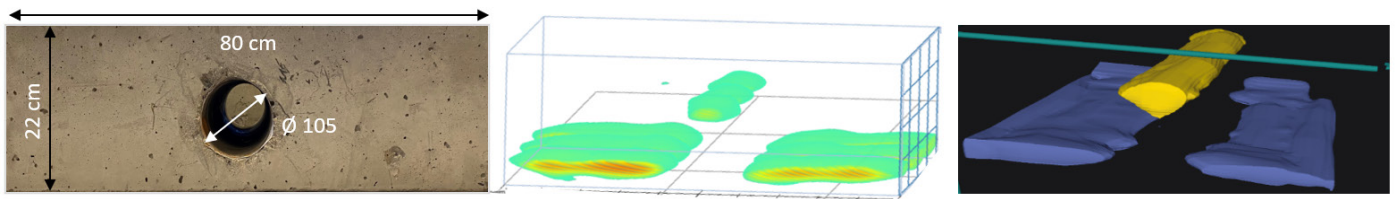
Figure 6: To the right is the concrete sample. 3D volume for Elop Insight scanner using 3 scan lines is shown in the middle figure whereas 3D volume generated for GPR using 14 scan lines are shown in figure to the right. The reflection from tendon duct around 8 cm is clearly visible together with back-wall echo at 22 cm in both images. However, in practical applications it is important to detect the voids in the tendon duct where ultrasound scanner performs much better than the GPR counterpart.

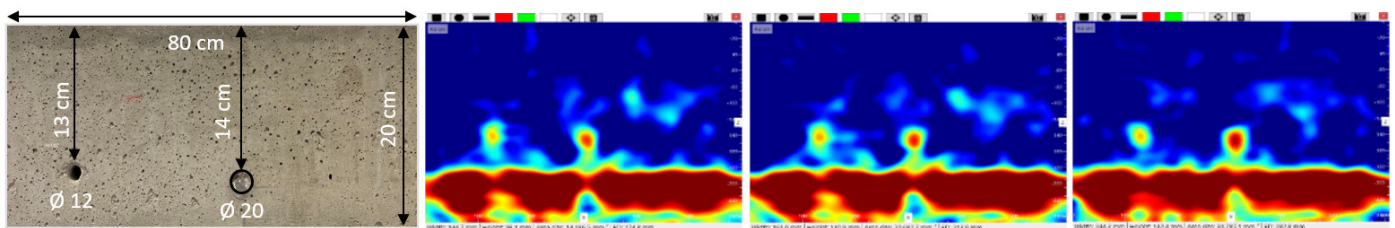
Figure 7: Concrete specimen S-18-1-2 has a rebar of 20 mm diameter at 14 cm from the top surface and a drilled hole of 12 mm diameter at 13 cm from the top surface. The drilled hole is 40 cm in length. Both drilled hole and the rebar are clearly visible along with the backwall echo in all D-scan images. The results are repeatable with minor variations in noise/artifact.

For testing repeatability of Elop Insight, the concrete specimens were scanned along the same scan line for ten times. The setting for transmitter pulse/voltage, receiver analog gain, and applied pressure were kept the same for all the measurements. The scanner was also rolled at a constant speed. While analyzing the image, the threshold for the 2D/3D image was also kept the same and D-scan slices at central plane were chosen for comparison for all ten measurements. Some of the representative images for a concrete specimen are shown in the figures below.

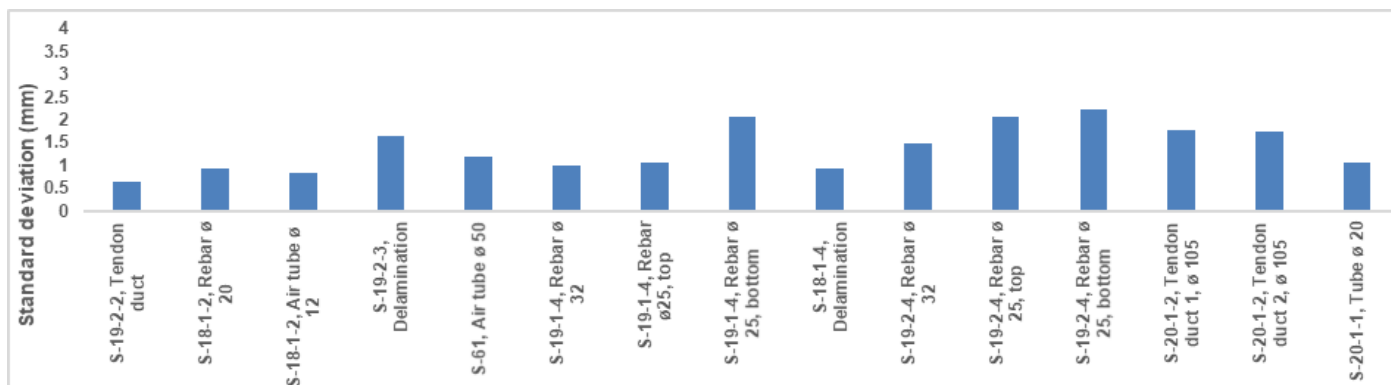
Figure 8: 3D Standard deviation (mm) in position for different features/reflectors in the concrete specimen.

From all the measurements in each of the concrete specimen, the position of the feature/reflector is calculated. For each concrete specimen, the deviation in position from the average value is also calculated which shows that the deviation in position from average is within ± 5 mm for all the concrete specimen. Using these values, standard deviation was calculated for position of features in all the concrete specimen. This is found to be within 2.5 mm for all the features and concrete specimen.
