# Seeing beneath the surface

- a performance comparison of non-destructive technologies for concrete inspection

Sanat Wagle, PhD, Elop AS Kamal Raj Chapagain, PhD, Elop AS December, 2020

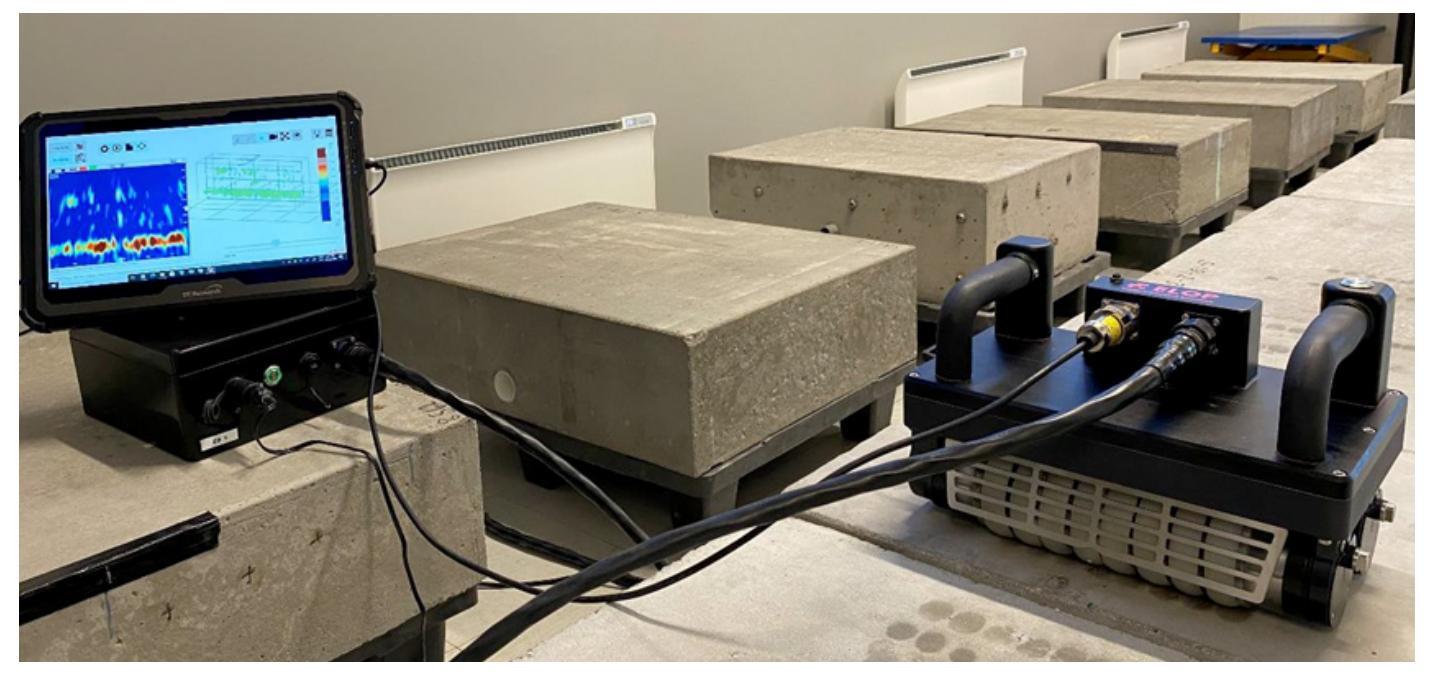
Test setup with 10 different concrete specimens

The following pages summarize the results of a number of tests and comparisons, carried out at Elop's R&D facility in Hamar, Norway. To compare the performance of different nondestructive inspection technologies we have used 10 concrete specimens, each with different characteristics, e.g. concrete mix ratio, density, and thickness of rebars, cracks, air pockets, delamination, drilled holes, tendon ducts etc. Measurements have been performed with four different instruments: Impact echo, UPV, Ultrasound Tomography, and Elop Insight scanner, to compare the capabilities of the Elop Insight scanner to these technologies. Also, the test measures the repeatability of the Elop Insight scanner under the same measurement conditions.

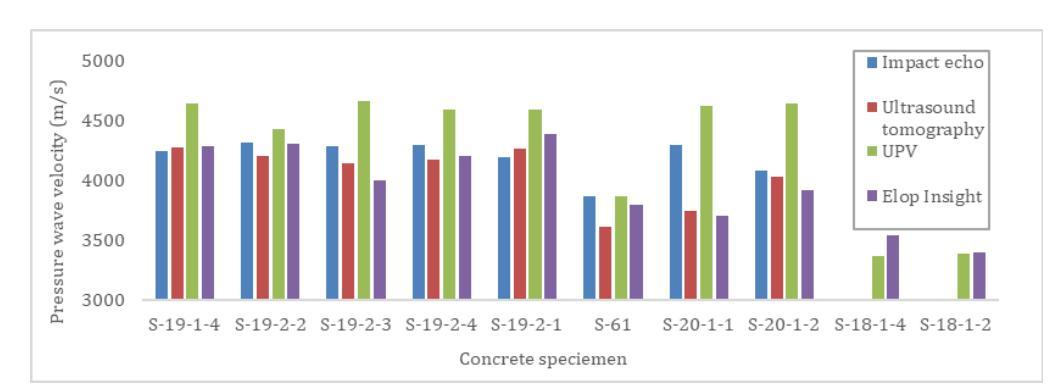
#### Figure 2:

Pressure wave velocity calculated from different instruments for different concrete specimen, named as S-61, S-18-1-2, S-18-1-4, S-19-1-4, S-19-2-1, S-19-2-2, S-19-2-3, S-19-2-4, S-20-1-1 and S-20-1-2

As we can see from the figure, the pressure wave velocities measured from different techniques are very close (within 5-10 %). The results obtained from UPV are generally slightly higher than obtained by other equipment (10-15%). The impact echo was not giving correct values when it was measured on the surface above rebars. The obtained velocities from Elop Insight were also verified by the backwall location from 3D images generated by Elop Insight.

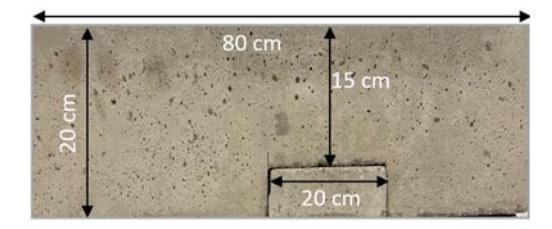
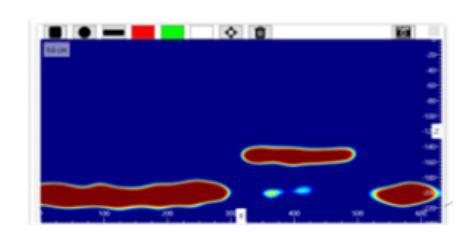
#### Figure 3:

Concrete specimen S-18-1-4 has a delamination of area 20 cm x 60 cm at 15 cm from the top surface. The gap between the two concrete blocks is in mm range. D-scan images of the concrete specimen for the central slice obtained from Elop Insight is shown in the left figure. The figure to the right is the slice obtained using Ultrasound tomography for the same specimen at the same location. The reflection from delamination around 15 cm is clearly visible together with back-wall echo at 20 cm in both the images.

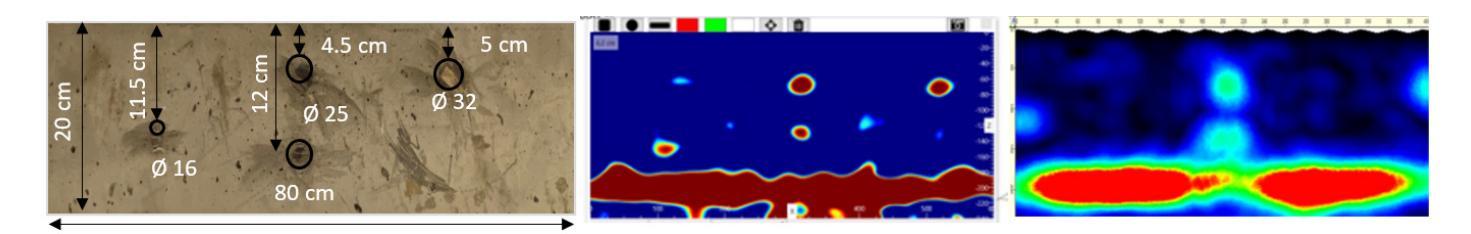
#### Figure 4:

Concrete specimen S-19-1-4 has four rebars with diameters 16 mm, 25 mm, and 32 mm at different locations. D-scan images of the concrete specimen for the central slice obtained from Elop Insight is shown in the left figure. We see clear reflections for all the rebars along with back-wall. The figure to the right is the slice obtained using Ultrasound tomography for the same specimen at the same location which also shows the presence of all four rebars.

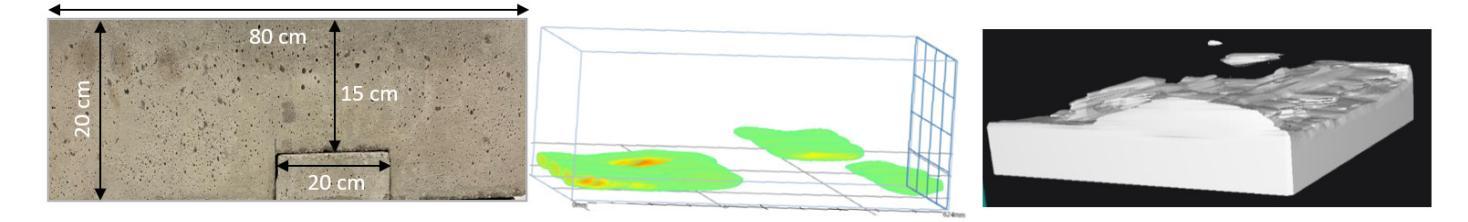
Figure 5: To the right is the concrete sample. 3D volume for Elop Insight scanner using 3 scan lines is shown in the middle figure whereas 3D volume generated for GPR using 14 scan lines is shown in figure to the right. The delamination gap between two concrete slabs is less than 5 mm. The delamination around 15 cm is clearly visible together with back-wall echo at 20 cm in Elop Insight. However, for GPR, the delamination was not clearly visible.

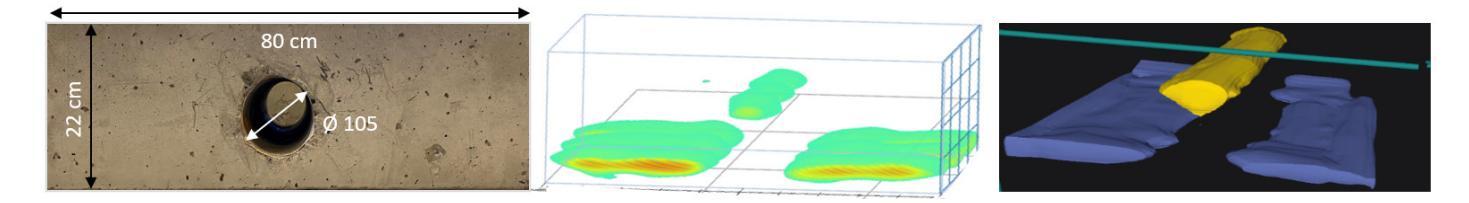
Figure 6: To the right is the concrete sample. 3D volume for Elop Insight scanner using 3 scan lines is shown in the middle figure whereas 3D volume generated for GPR using 14 scan lines are shown in figure to the right. The reflection from tendon duct around 8 cm is clearly visible together with back-wall echo at 22 cm in both images. However, in practical applications it is important to detect the voids in the tendon duct where ultrasound scanner performs much better than the GPR counterpart.

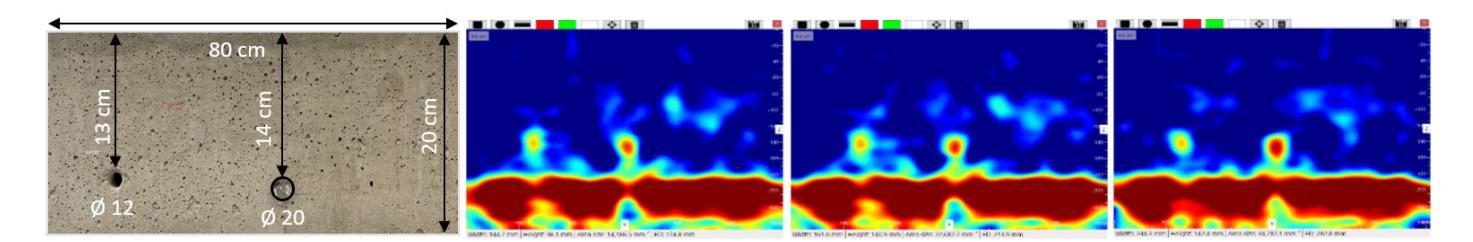
Figure 7: Concrete specimen S-18-1-2 has a rebar of 20 mm diameter at 14 cm from the top surface and a drilled hole of 12 mm diameter at 13 cm from the top surface. The drilled hole is 40 cm in length. Both drilled hole and the rebar are clearly visible along with the backwall echo in all D-scan images. The results are repeatable with minor variations in noise/artifact.

For testing repeatability of Elop Insight, the concrete specimens were scanned along the same scan line for ten times. The setting for transmitter pulse/voltage, receiver analog gain, and applied pressure were kept the same for all the measurements. The scanner was also rolled at a constant speed. While analyzing the image, the threshold for the 2D/3D image was also kept the same and D-scan slices at central plane were chosen for comparison for all ten measurements. Some of the representative images for a concrete specimen are shown in the figures below.

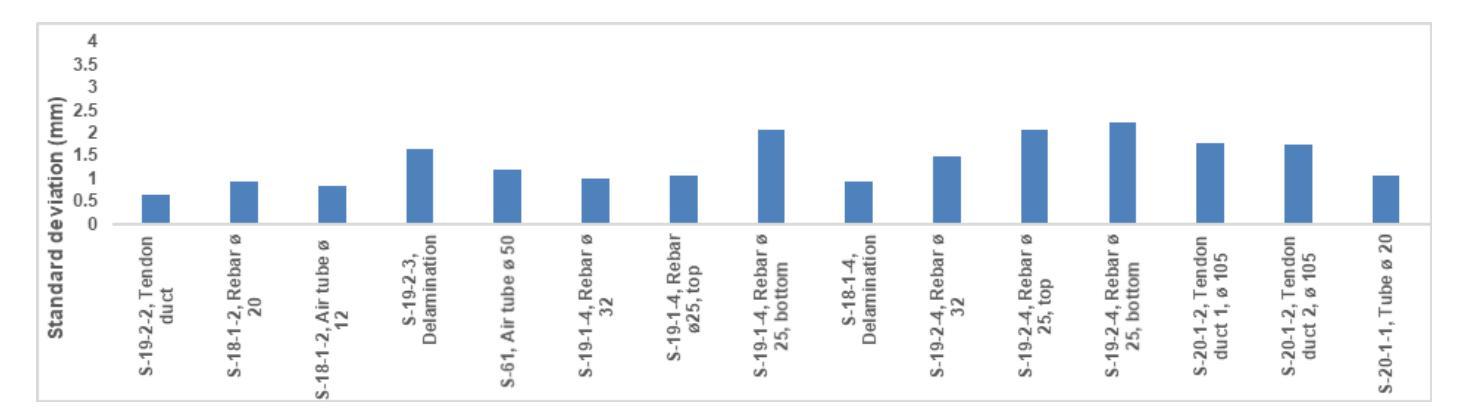
Figure 8: 3D Standard deviation (mm) in position for different features/reflectors in the concrete specimen.

From all the measurements in each of the concrete specimen, the position of the feature/reflector is calculated. For each concrete specimen, the deviation in position from the average value is also calculated which shows that the deviation in position from average is within ± 5 mm for all the concrete specimen. Using these values, standard deviation was calculated for position of features in all the concrete specimen. This is found to be within 2.5 mm for all the features and concrete specimen.
